Wilson, R., Harrison, S., Reynolds, J., Hubbard, A., Glasser, N. F., Wünderlich, O., Iribarren Anaconda, P., Mao, L., & Shannon, S. (2019). The 2015 Chileno Valley glacial lake outburst flood, Patagonia. *Geomorphology*, 332, 51-65.
<https://doi.org/10.1016/j.geomorph.2019.01.015>

The 2015 Chileno Valley glacial lake outburst flood, Patagonia

Glacial Lake Outburst Floods (GLOFs) have become increasingly common over the past century in response to climate change, posing risks for human activities in many mountain regions. In this paper we document and reconstruct the sequence of events and impact of a large GLOF that took place in December 2015 in the Chileno Valley, Patagonia. Hydrograph data suggests that the flood continued for around eight days with an estimated total discharge of $105.6 \times 10^6 \text{ m}^3$ of water. The sequence of events was as follows: (1) A large debris flow entered the lake from two steep and largely non-vegetated mountain gullies located northeast of the Chileno Glacier terminus. (2) Water displaced in the lake by the debris flow increased the discharge through the Chileno Lake outflow. (3) Lake and moraine sediments were eroded by the flood. (4) Er

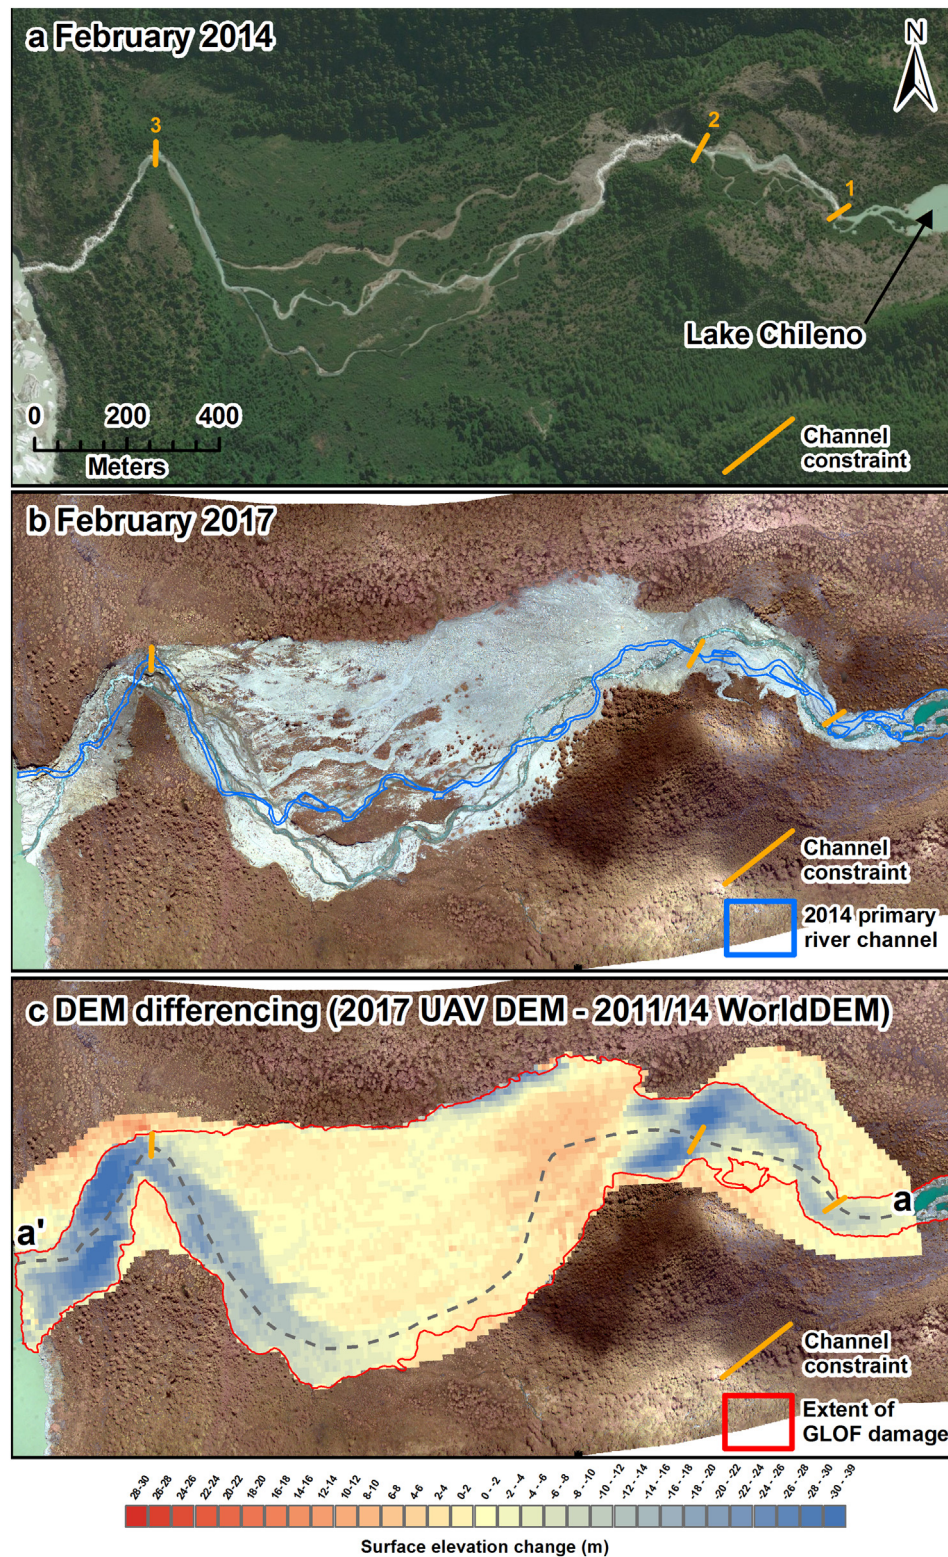
Fig. 4. Geomorphology of the Chileno Valley before (a) and after (b) the GLOF event that occurred in December 2015. Post-GLOF surface elevation changes are shown in image (c).

The impacts of the Lake Chileno GLOF on the valley below are visually illustrated in Figs. 4–7. Impounded by the ridge of the overdeepened deglaciated basin of Chileno Glacier, Lake Chileno was initially drained via an overflow outlet located ~550 m upstream of an incised LIA moraine. Pre-GLOF, this overflow channel met two constraining points along the proximal channel (see Fig. 4a), where it dropped in elevation by ~6 m and ~48 m along reaches of 50 m and 230 m, respectively.

morphology flanked on either side by steep-sided scarps (see Fig. 4b). At the initial breaching zone (channel constraint 1 – see Fig. 4a) the surface of the river channel lowered by an average of 8.9 ± 1.5 m with the river bank at this point widening by around 60 m. Furthermore, as a result of the GLOF, the river channel changed course and is now located 20 m to the south of the initial breaching zone (see Fig. 4b). Approaching what was the second channel constraint, the post-GLOF channel has in many sections widened by >100 m, these areas having lowered in elevation by $>30 \pm 1.5$ m in places (Fig. 4c). The observation of areas of re-sedimented deposits along this reach also suggests that sediment was removed from Lake Chileno during the GLOF event (see Table 3 and Fig. 7b). The LIA terminal moraine that encompasses the proximal channel is at its peak around 35 m high. Post-GLOF erosion adjacent to its crest of this moraine (See Figs. 6 and 8), shows that it is composed of a series of stacked

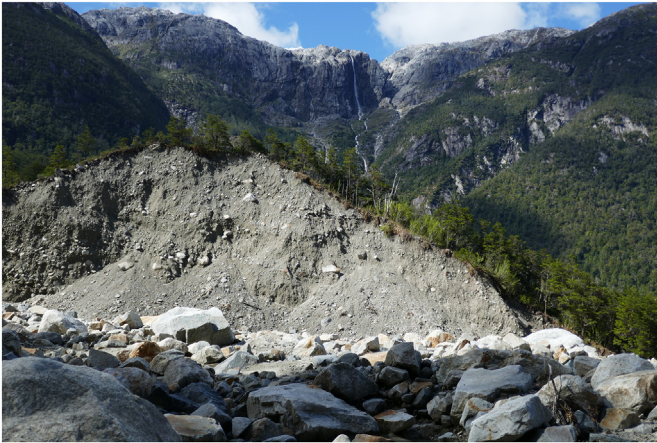
Fig. 8. Field photography captured in February 2017 illustrating the post-GLOF erosion of the LIA moraine crest (see Fig. 6 for location). The crest of the LIA moraine is up to 35 m high and composed of a series of stacked sedimentary units made of matrix-supported and poorly-sorted bouldery diamict. The units are from 1 to 2 m in thickness and dip downvalley at angles of up to 10°. Clasts are mainly subrounded to sub-angular and blocky, and up to 2 m in b-axis.
